Project No. 5404G Date: August 10, 2005 Tested at Humboldt

Final Report

Reducing Canola Seed Damage from Metering and Air Distribution Systems

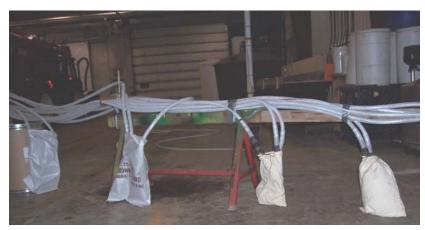
Figure 2. Plastic and Cloth Bags Used to Catch Seeds.

Conserva-Pak: The Conserva-Pak system included a tow between Conserva-Pak 4400 air cart with 112 hoses running behind the air cart. The air cart consisted of two smaller tanks and two larger tanks. There were 56 hoses for the left metering bank and 56 hoses for the right metering bank (Figure 1). The 56 hoses on both the left and right bank is divided into two groups of 28 hoses. The top 28 hoses ran the small and large tank on the rear while the bottom 28 hoses ran the large and small tank in the front of the air cart. The 28 hoses that were used had production length hoses connected to them to simulate half of a 56 ft seeder. The 28 hoses that were used had Conserva-Pak openers on them and were placed in plastic and cloth bags to catch the seed (Figure 2).

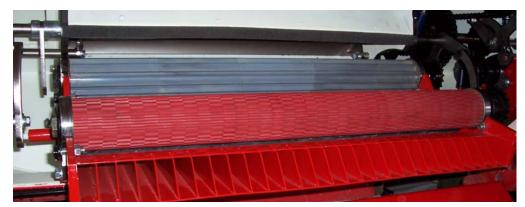
Figure 3. Fine and Medium Rollers.

A hydraulic motor with a flow control valve was mounted on the end of the metering drive wheel shaft and was used to simulate target ground speeds. A fine roller was used to meter the canola and a medium roller was used to meter the phosphate (**Figure 3**). Half of the small front tank was used for the seed due to the small seeding volumes associated with canola (**Figure 4**).

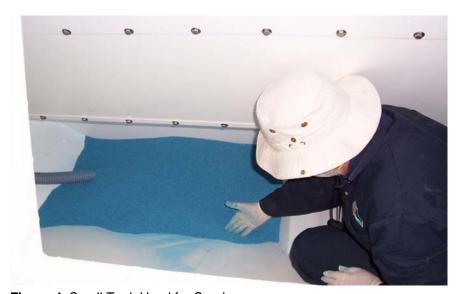
Figure 4. Small Tank Used for Seed.

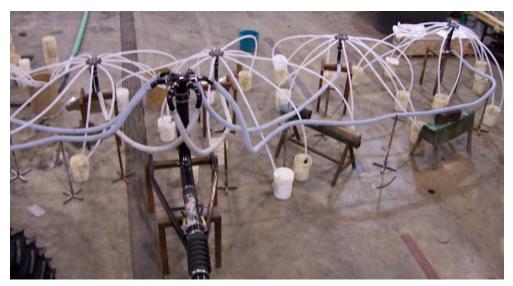
Figure 5. Air Kit Mounted on Test Stands.

Bourgault: The Bourgault system included a tow behind Bourgault 6550 air cart with an air kit mounted on test stands (**Figure 5**). Seed and fertilizer were metered from the air tank with an auger type system into one large primary distribution hose. The canola meter used a double fluted steel auger (**Figure 6**) while the fertilizer meter had a single

flight polyurethane auger. The primary hose ran past the rear of the air cart where it entered the bottom of the primary manifold with six outlets. Each of these hoses ran into a secondary manifold with 11 delivery hoses (**Figure 5**). The delivery hoses were inserted into plastic pails with cloth on the bottom to absorb the impact at the bottom of the pail. The standard Bourgault boots were very streamlined and probably would have caused little or no seed damage. They were left off of the hoses to help speed up the testing process. However, to verify this, additional tests were run after completion of the tests using the standard square Bourgault boot and Bourgault Tillage Tools 200-KNf-7510 narrow opener. When seeding with a Bourgault seeder, phosphate is always run with the seed. All of Bourgault's runs had phosphate included except for one run which was base minus P.

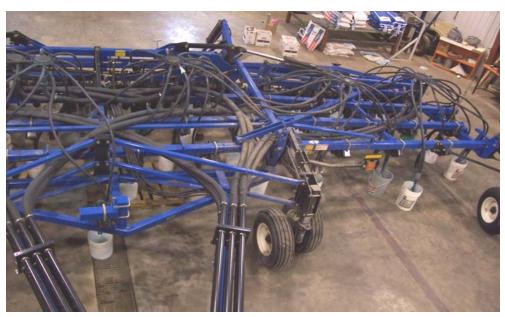
Figure 9. Pail Set-up.
